# Manhole Inspection Summary

Manhole # S05WW1003MH

**Location** Address: **5816 HIGH GATE DR**

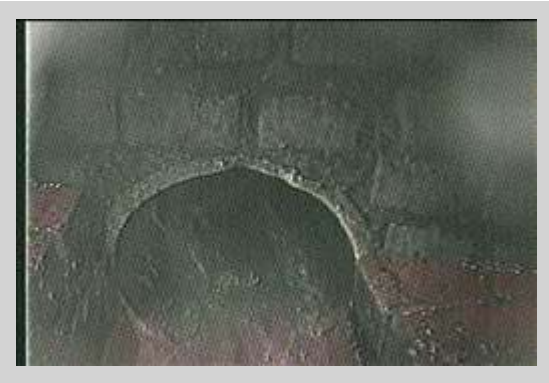
### 10 in. Circular Gravity Sewer Pipe Out @ 12 O'Clock

Rod and Bar (Angled)

Infiltration: **None** Pipe Seal Cond: **Unknown**
